## SCOPE OF WORK: ANNEXURE A

### Background

The facility operates six (6) crude oil underground storage tanks, each approximately 240 m × 240 m. Each tank top is fitted with a 1.5 mm thick High-Density Polyethylene (HDPE) geomembrane outer liner, covering the full tank surface and divided into four (4) structural slabs.

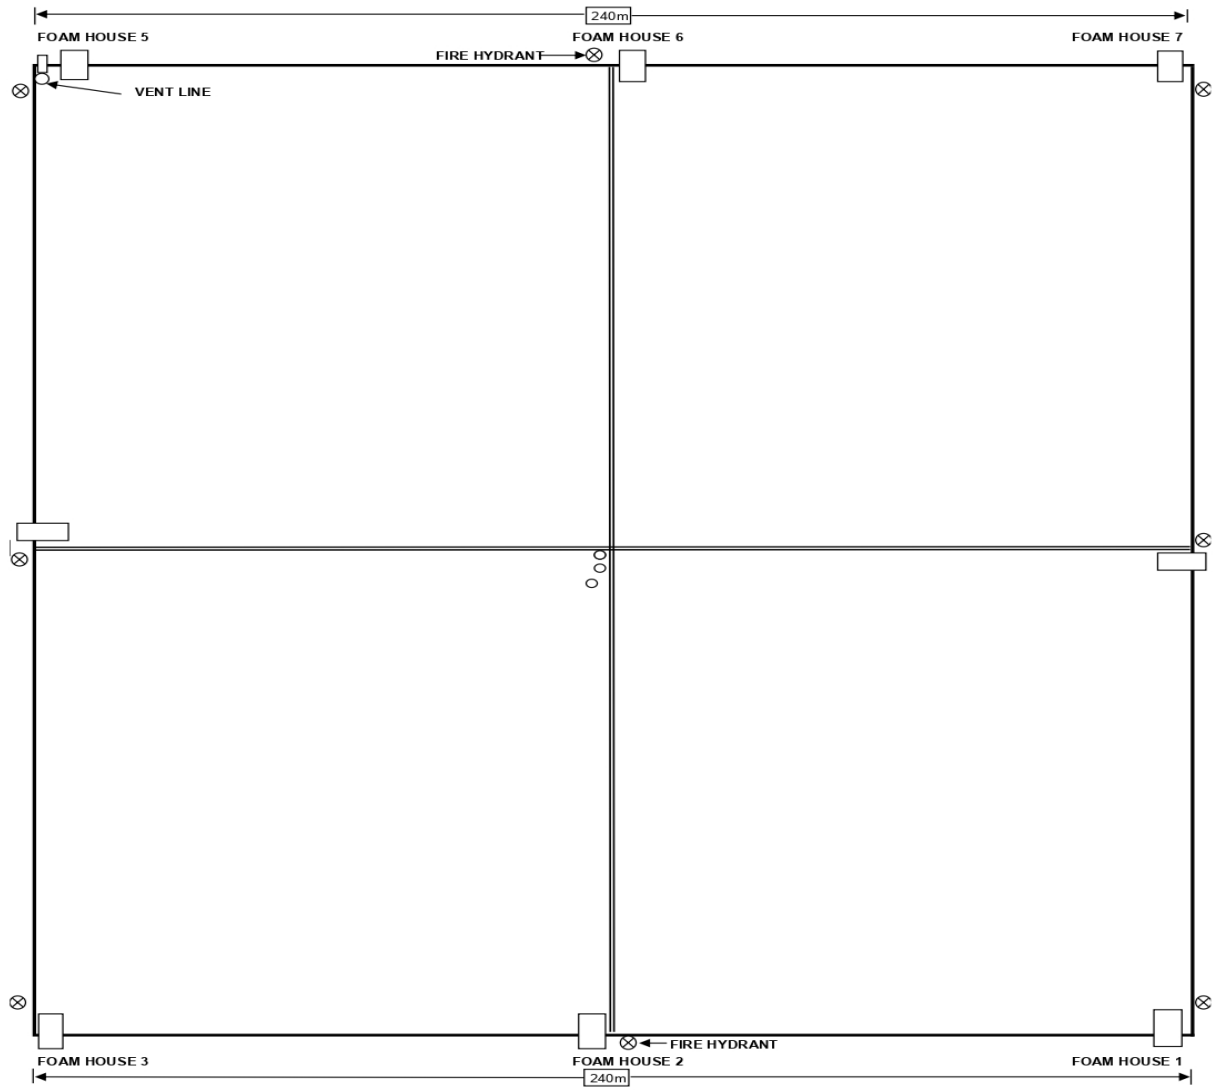
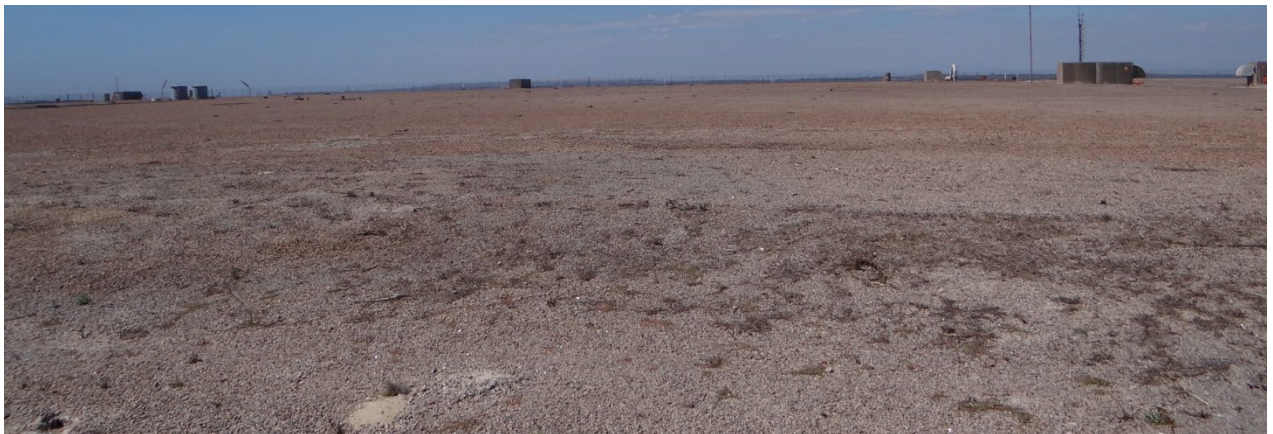
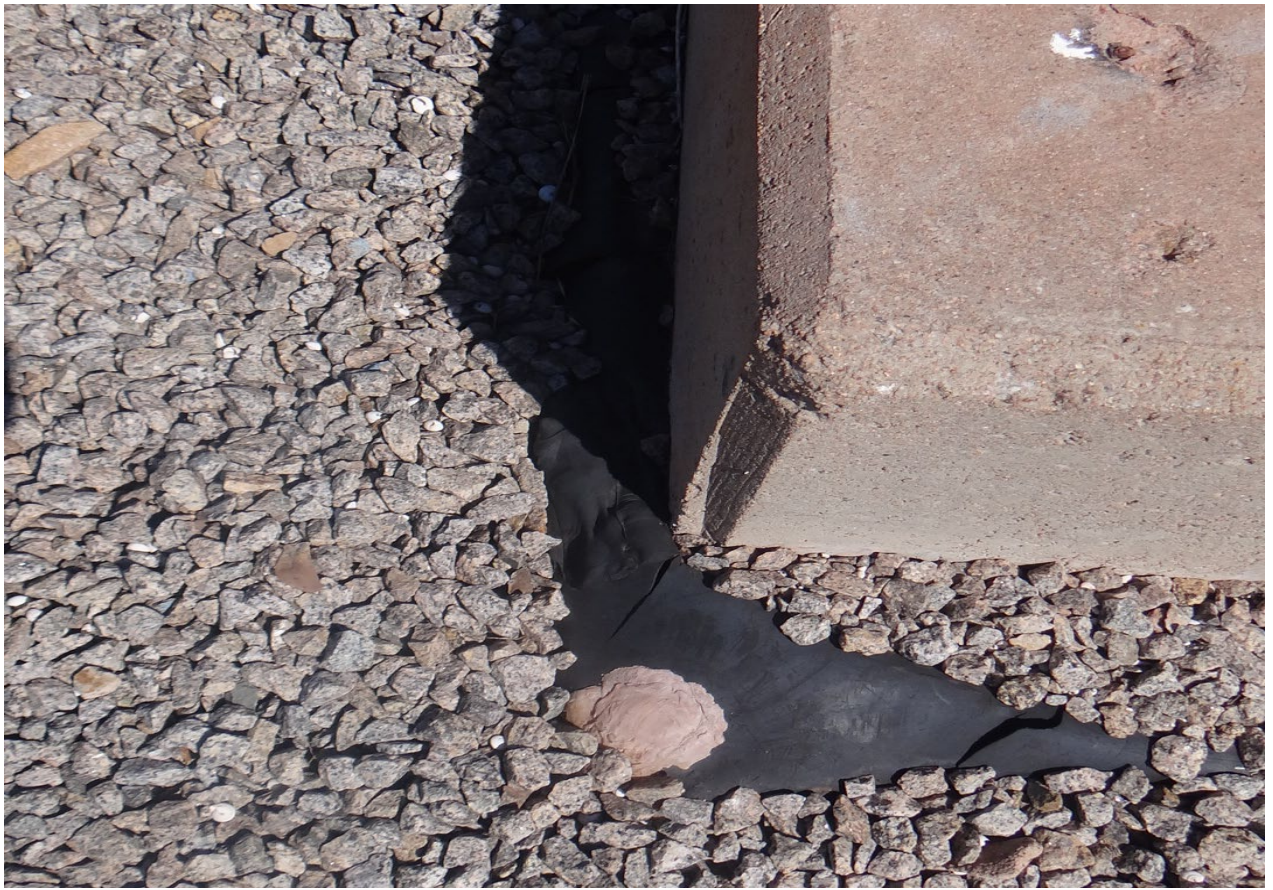
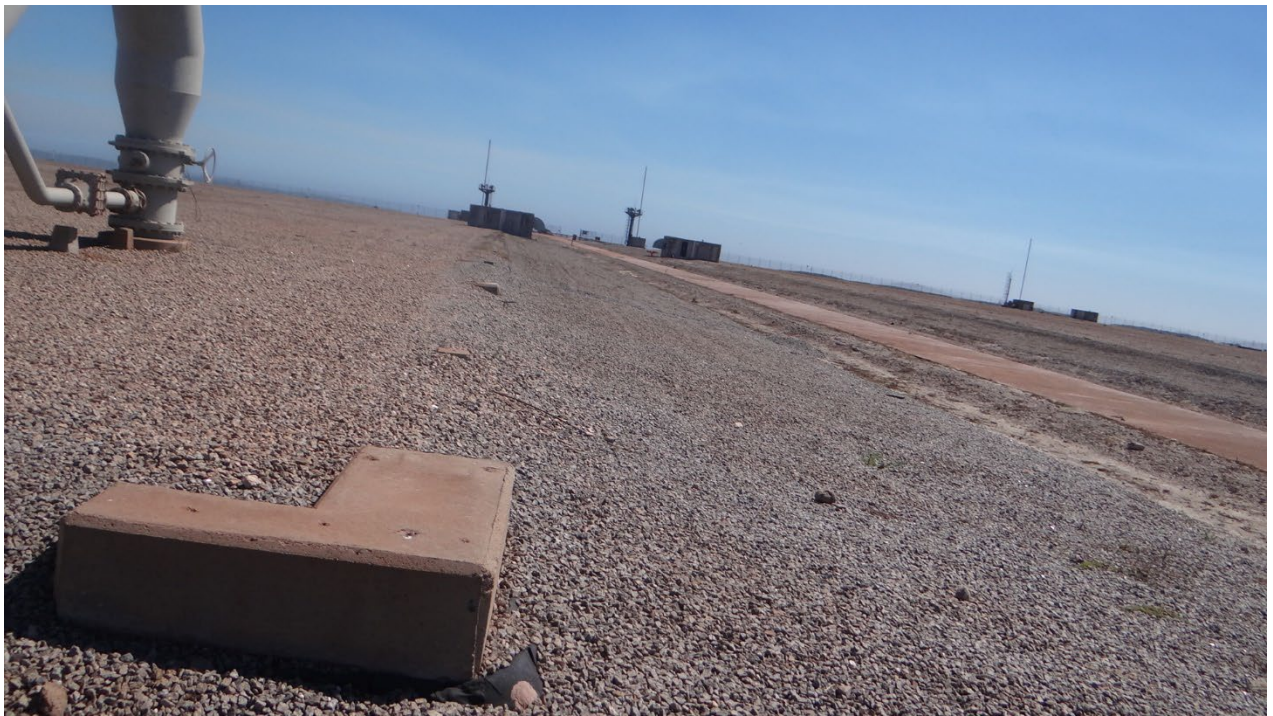
# ARRANGEMENT OF TANK ROOF

The HDPE liner is covered with fine gravel, which discolours brown when gas leaks occur.

The tank top is a flat surface, and no working at height is required. The tanks will remain in service containing crude oil during execution of the works.
